**DETERMINATION OF OPTIMUM FABRICATION
TECHNIQUES FOR THE PRODUCTION OF
AUSTENITIC REFRACTORY BIMETALLIC TUBING
MIDPOINT REPORT**

National Aeronautics and Space Administration

Lewis Research Center

Westinghouse Electric Corporation

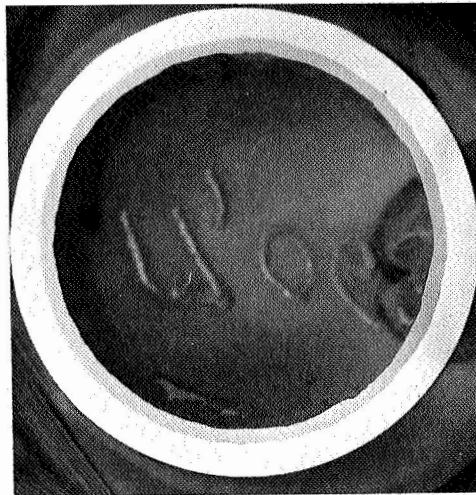
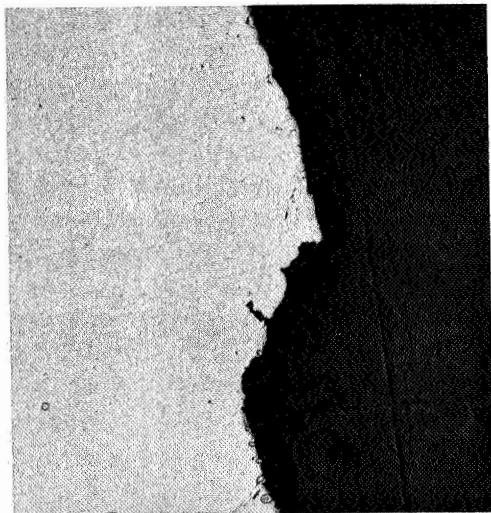
Figure 6. As-Received Metalonics Ta/316SS Bimetal Tubing

- a) a rough interface
- b) an ID surface roughened by longitudinal striations about 2-3 mils deep and occasional cracks of varying depth
- c) a smooth OD surface containing several cracks of varying depth.

(a) Transverse Section 3X

(b) ID Crack, ~2 Mils Deep 100X

(c) OD Crack ~7-1/2 Mils Deep 100X

Extensive sectioning of the type of tubing seems to indicate that the majority of the cracks identified by dye penetrant testing of the OD are about 5 mils deep and also that the majority of ID cracks are about 2-3 mils deep. (See Figure 6)

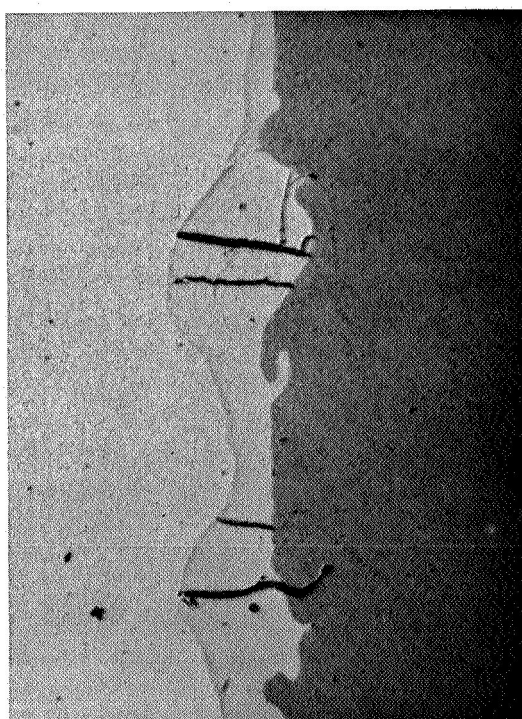
Figure 10. Typical Interface in As-Explosively Bonded to Size Tubing

Transverse sections were taken every 12 inches along the length of the 96 inch length of explosively bonded tubing and examined metallographically. As shown in Figure 10, an intermetallic layer was formed at the interface during bonding. The layer appears to be continuous and microprobe analysis will be used to identify its composition. Transverse cracks were also observed in this intermetallic layer which in some instances propagated into the tantalum liner. The intermetallic layer was observed on 75 percent of the samples examined and was formed almost continuously around the diameter. Longitudinal sectioning (see Figure 5a) showed the thickness of each of the components to be uniform except in the area where a stand off dimple was made. Here the dimple protuberance is reflected in both layers by a kink.

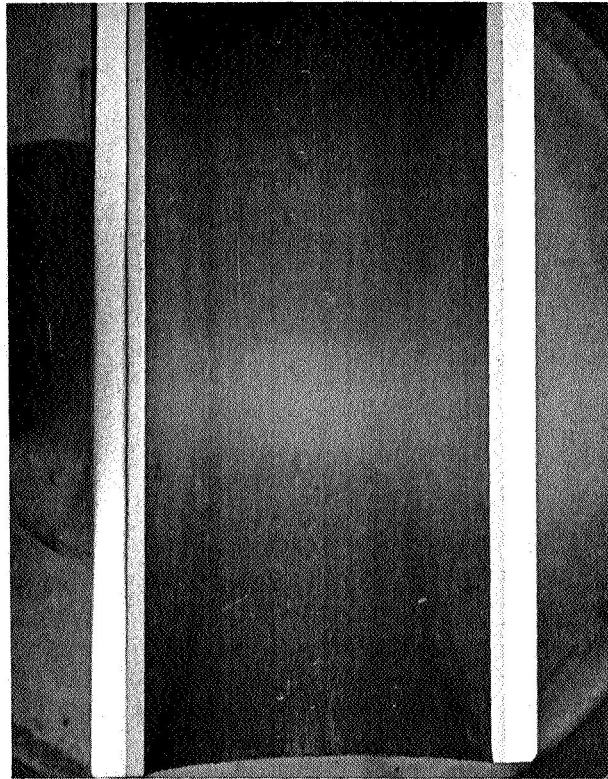
Figure 11. Longitudinal Section of Metalonics Tubing

As previously discussed the interface of this lot of tubing is extremely rough. Figure 11 shows a typical longitudinal section which illustrates the thickness of the individual bimetal layers to be quite uniform.
